City of Burnsville

Transition Plan

Ice Arena

JQP, Inc. Accessibility Consultants

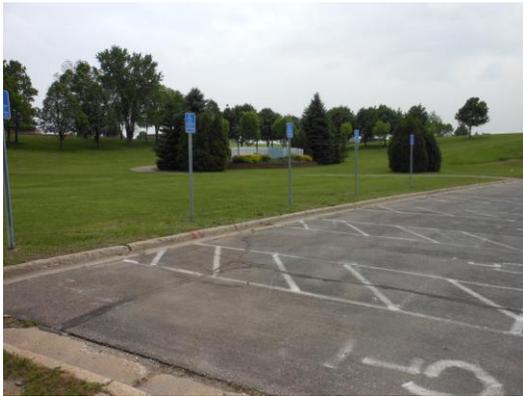
14093	<i>Restripe the parking to add an aisle in front of the curb cut. The curb cut can be blocked by parked vehicles. Photo 2.</i>	1			3				
05A 14094	Stripe an appropriate number of accessible parking stalls and provide appropriate permanent signage. IBC 1106.1 <i>There are currently 6 spaces designated as accessible (5 near the ice arena, 1 near the skate park), based on the total quantity of parking, a minimum of 8 spaces are required.</i>	2	\$400	\$800	3				
05H 14092	Stripe to provide an accessible parking stall that is 8' wide with an adjacent 8' access aisle. It is preferred that the access aisle be located on the passenger side of the vehicle. MN 1341 502.4.2 <i>Currently 3 of the parking spaces are have 5' wide aisles, 2 share an 8' aisle. Photo 1.</i>	3	\$150	\$450	3

Photo 1: Restripe the accessible parking spaces to provide 8' wide aisles for each space (can be shared by 2 spaces). Lower the signs to 60"-66" (currently at 90").

05E	<i>14095</i>	Relocate the sign identifying each designated accessible parking stall, so centered at the head end of the parking space and mounted 60"-66" above the floor (measured to the bottom of the sign). MN1341 502.7 <i>Currently at 90".</i>	1	\$250	\$250	4			
------------	--------------	--	---	-------	-------	---	--	--	--

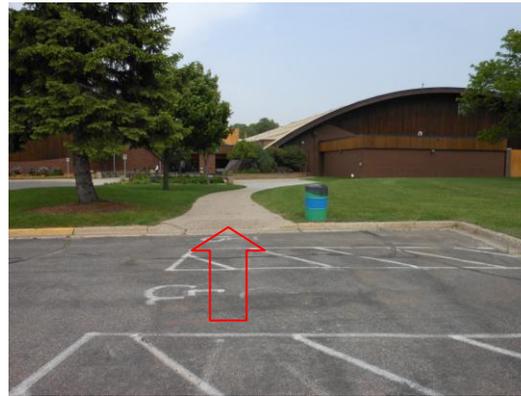
Photo 2: When restriping the parking lot, provide an aisle adjacent to the curb ramp to prevent a vehicle from blocking the route.

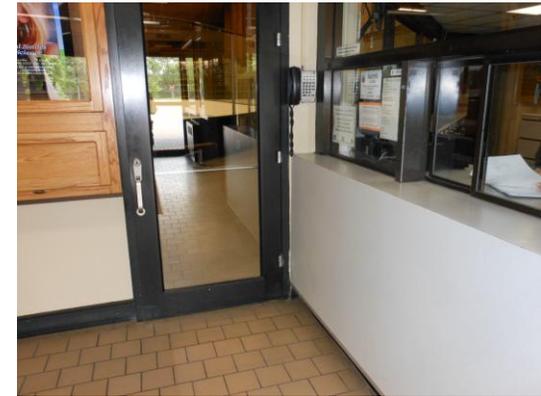
21A1	<i>14089</i>	Lower a minimum 36" wide section of counter to a maximum height of 36" above the floor. ICC ANSI 904.3 <i>The service counter is currently at 39 1/2". Photo 3.</i>	1	\$1,000	\$1,000	3			
-------------	--------------	---	---	---------	---------	---	--	--	--

Photo 3: Lower the service counter to 36" maximum (currently at 39 1/2").

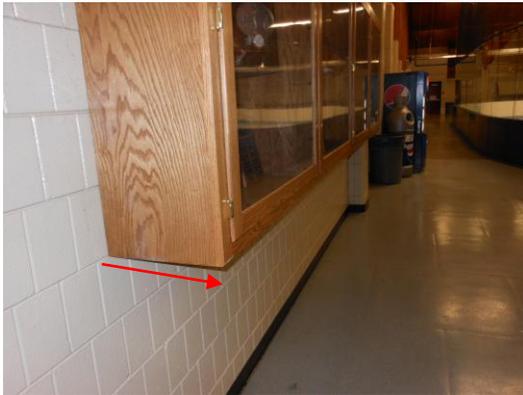
Photo 4: Eliminate the protruding hazard at the display case at Rink 2.

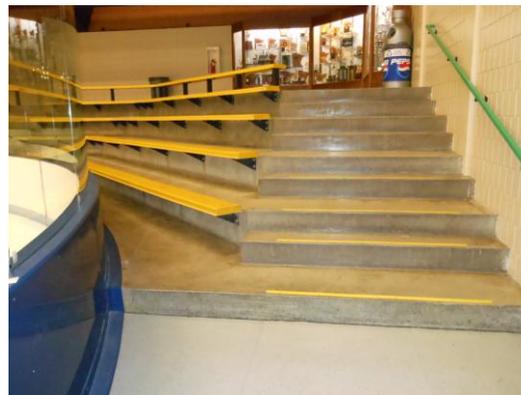
Location	Solution / Comments	Qty	Unit Cost	Total Cost	Priority	Estimated Compl. Date	Person Responsible	Actual Compl. Date	Actual Cost
Rink 1- Visitor Seating									
26D1	14071 Identify accessible viewing positions. IBC Table 1108.2.2.1 <i>The permanent concrete bleachers do not currently provide wheelchair positions. The policy currently allows visitors to drive up to the door and enter from the rear where space is available for wheelchair viewing positions. Photos 5 and 6.</i>	1	\$0	\$0	3				
Rink 2									
14G1	14004 Eliminate protruding hazard by installing end panels or other object to direct a person with visual impairments using proper cane technique around the potential hazard. ICC / ANSI 307.1 <i>The display case currently protrudes 15" at a height of 40 1/2". Photo 4.</i>	1	\$200	\$200	3				
26D1	14005 Identify accessible viewing positions. IBC Table 1108.2.2.1 <i>Based on the quantity of seating provided in the pull out bleachers, a minimum of 5 wheelchair positions are required.</i>	1	\$0	\$0	3

Photo 5: View of spectator seating on the visitor side of Rink 1. There is not currently accessible viewing positions that are integrated with the bleachers.

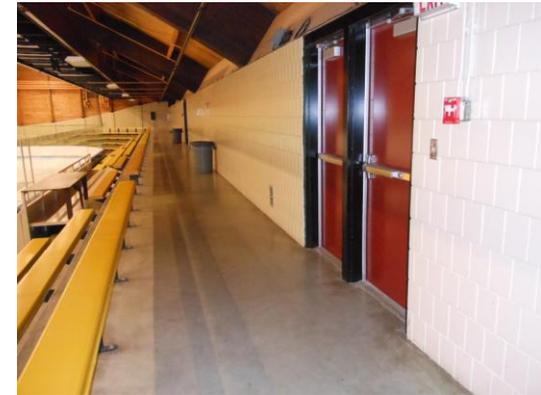
Photo 6: View of spectator seating on the visitor side of Rink 1. Currently spectators are allowed to drive to the back of the building and enter into the upper level of the spectator seating area for accessible viewing.

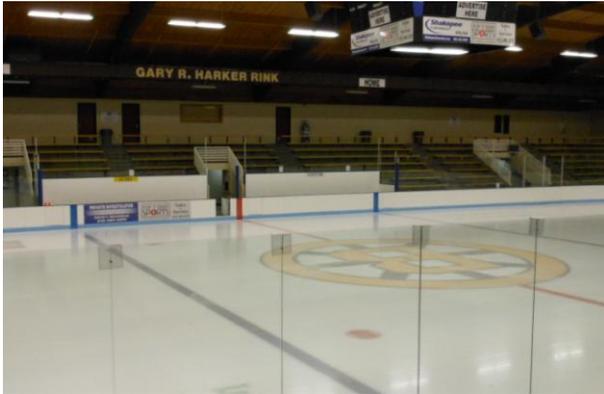
26D1 14086	Identify accessible viewing positions. IBC Table 1108.2.2.1 <i>The bleachers on the home side load from above; there is not currently an accessible route. Photo 7.</i>	1	\$0	\$0	3				
-------------------	---	---	-----	-----	---	--	--	--	--

Photo 7: View of spectator seating on the home side of Rink 1. The bleacher system is loaded from above/back. There is not currently an accessible route to the spectator seating area.

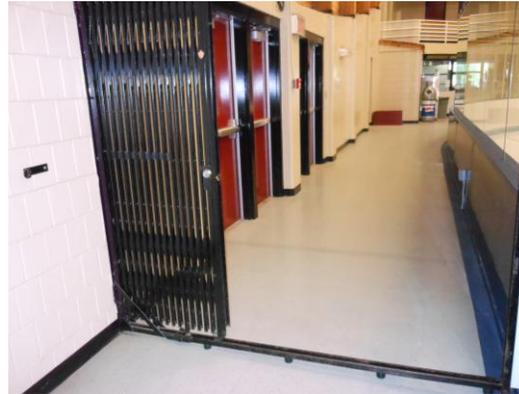
Location	Solution / Comments	Qty	Unit Cost	Total Cost	Priority	Estimated Compl. Date	Person Responsible	Actual Compl. Date	Actual Cost
JQP # / Item #									
Concessions Rink 2- Condiment Counter									
14G	14019	1	\$50	\$50	2				
	Eliminate protruding hazard by positioning an object below. This will create a detectable object to direct a person with a visual impairment using proper cane technique around the protruding object. ICC / ANSI 307.1 <i>The counter currently protrudes 15" at a height of 42".</i>								
Rink 1- Visitor Seating									
14C	14070	1	\$100	\$100	2				
	Bevel abrupt rise between 1/4" and 1/2" with a maximum slope of 1:2, and bevel abrupt rises greater than 1/2" with a maximum slope of 1:12 (8.33%). ICC / ANSI 303.3 <i>The route to the visitor seating requires passing through a gate that has a track on the bottom. Photo 8.</i>								
				Priority # 2 Total		\$150

Photo 8: The gate system at Rink 1 requires stepping over the bottom track of the gate. (It appears that the gate may be able to pivot in order to move the track out of the route of travel.)

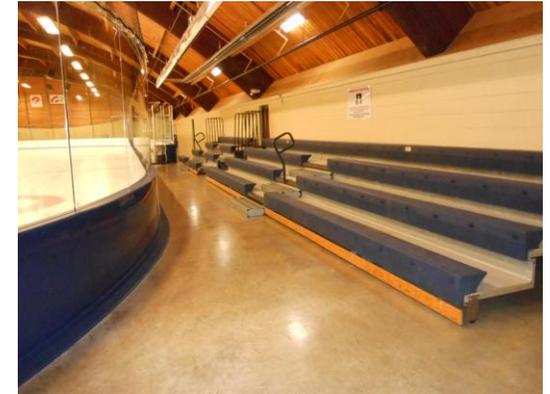
Photo 9: View of spectator seating at Rink 2. There is room adjacent to the bleachers for accessible viewing positions.

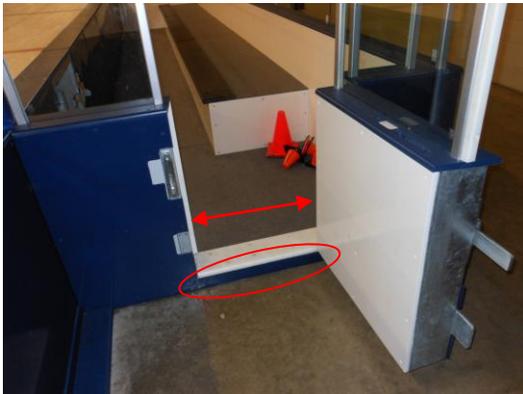
14C	<i>14069</i>	Bevel abrupt rise between 1/4" and 1/2" with a maximum slope of 1:2, and bevel abrupt rises greater than 1/2" with a maximum slope of 1:12 (8.33%). ICC / ANSI 303.3 <i>There is an 8" step down to the ice. Photo 10.</i>	1	\$100	\$100	4			
20A	<i>14068</i>	Widen door opening to provide a minimum 32" clear opening. ICC / ANSI 404.2.2 <i>The opening on to the ice is 23" clear. Photo 10.</i>	1	\$1,500	\$1,500	4

Photo 10: The opening into the player seating area and onto the ice currently provides a 23" clear opening. There is a 3 1/2" change of level.

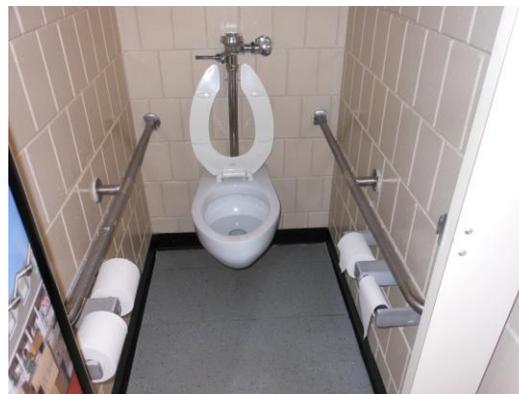
Photo 11: The multi-fixture toilet rooms provide ambulatory accessible toilet compartments.

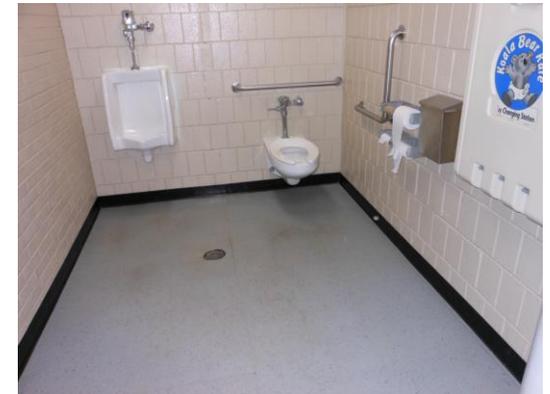
22K6 (MN)	14024 Remove the existing grab bar configuration and replace with a compliant grab bar configuration. MN 1341 604.5.1 ANSI 604.5.2 <i>Photo 12.</i>	1	\$400	\$400	4				
22W2	14026 Relocate the sanitary product receptacle in the accessible stall. The sanitary product receptacle should be located 1 1/2" minimum below the horizontal grab bar and 18" minimum above the floor and 12"-40" from the rear wall. MN 1341 604.7 <i>Photo 12.</i>	1	\$50	\$50	4				
22Y	14023 Lower urinal so the lip is no higher than 17" above the floor. ICC / ANSI 605.2 <i>Currently at 24". Lower or remove the urinal.</i>	1	\$650	\$650	4				
22Z8	14028 Relocate the folding changing tabe so the latch mechanism is located no higher than 54" above the floor. MN1341 603.5 <i>Currently at 55".</i>	1	\$50	\$50	4				
				<i>Location Subtotal:</i>					\$6,150

Photo 12: View of accessible toilet room that can be accessed from the corridor and the multi-fixture toilet room. Relocate the toilet paper dispenser and sanitary waste receptacle and replace the "L" grab bar with separate vertical and horizontal side wall grab bars.

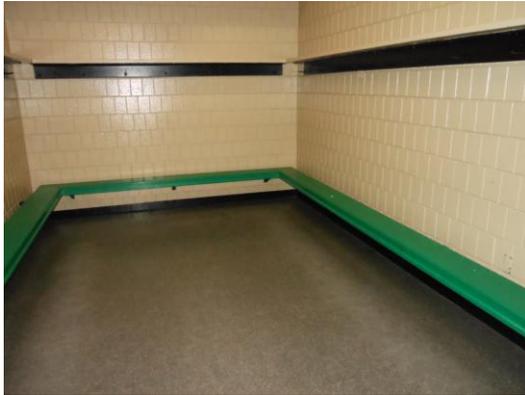
Location JQP # / Item #	Solution / Comments	Qty	Unit Cost	Total Cost	Priority	Estimated Compl. Date	Person Responsible	Actual Compl. Date	Actual Cost
Team Room- 6									
24V 14014	In the changing/locker room, provide a bench, 20"-24" deep x 48" long, fixed to the wall or with a back along the longer dimension. The bench is to be mounted 17"-19" above the floor at the accessible dressing room and provide clear floor space at the end of the bench. MN1341 903 <i>Photo 13.</i>	1	\$200	\$200	3				
40B 14013	Provide compliant raised and Braille permanent room identification signage. MN 1341 1110.2	1	\$40	\$40	3				
				<i>Location Subtotal:</i>					\$240
Team Room- 7									
24V 14012	In the changing/locker room, provide a bench, 20"-24" deep x 48" long, fixed to the wall or with a back along the longer dimension. The bench is to be mounted 17"-19" above the floor at the accessible dressing room and provide clear floor space at the end of the bench. MN1341 903 <i>Photo 13.</i>	1	\$200	\$200	3

Photo 13: View of typical team locker room.

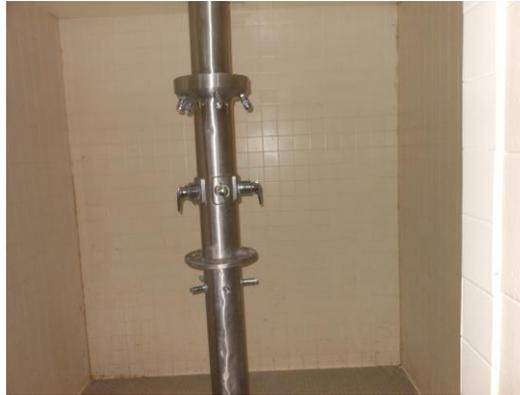
24.1	14059 Provide a fully compliant shower room. IBC 1109.2 <i>Photo 14.</i>	1	\$5,000	\$5,000	3				
				<i>Location Subtotal:</i>					<i>\$7,240</i>

Photo 14: The typical team locker room does not currently provide any features of accessibility.
